Town of Walton Streambank Stabilization at Beers Brook Site D
Before and After Photos

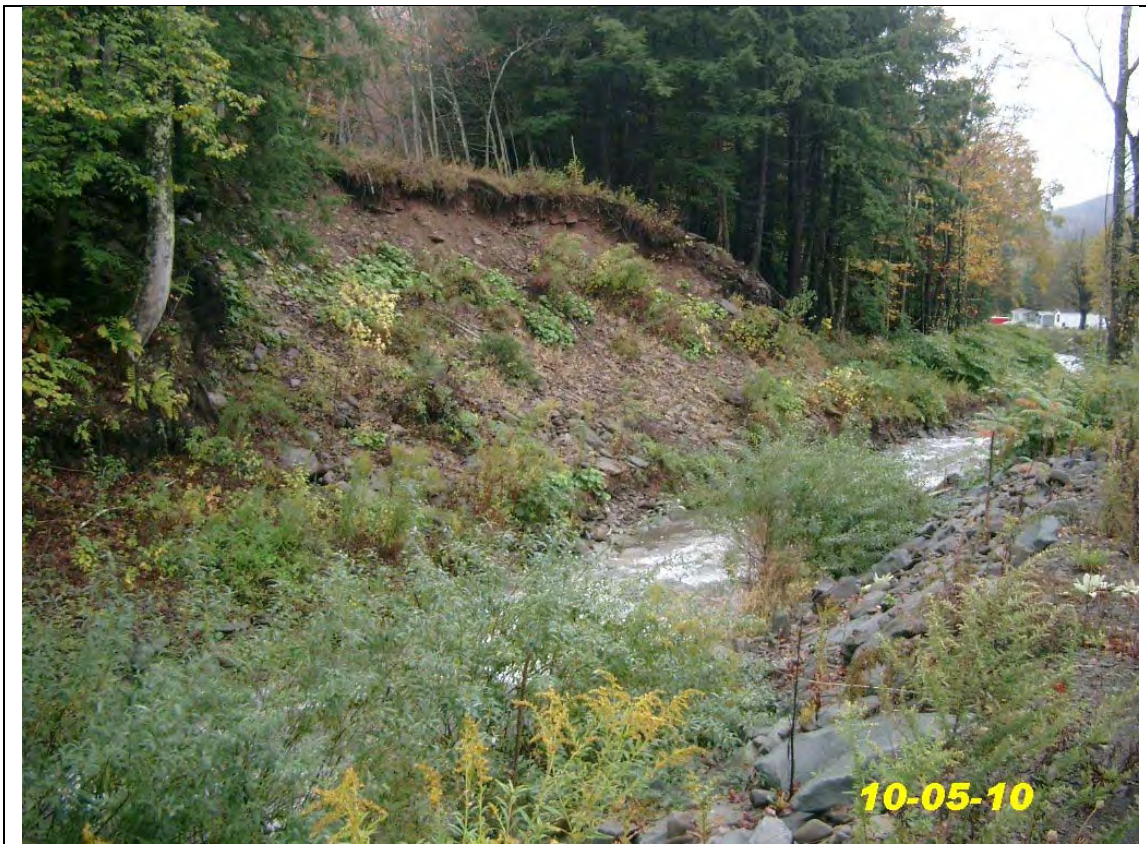
Photo 1: Looking downstream at left streambank erosion from Beers Brook Road.

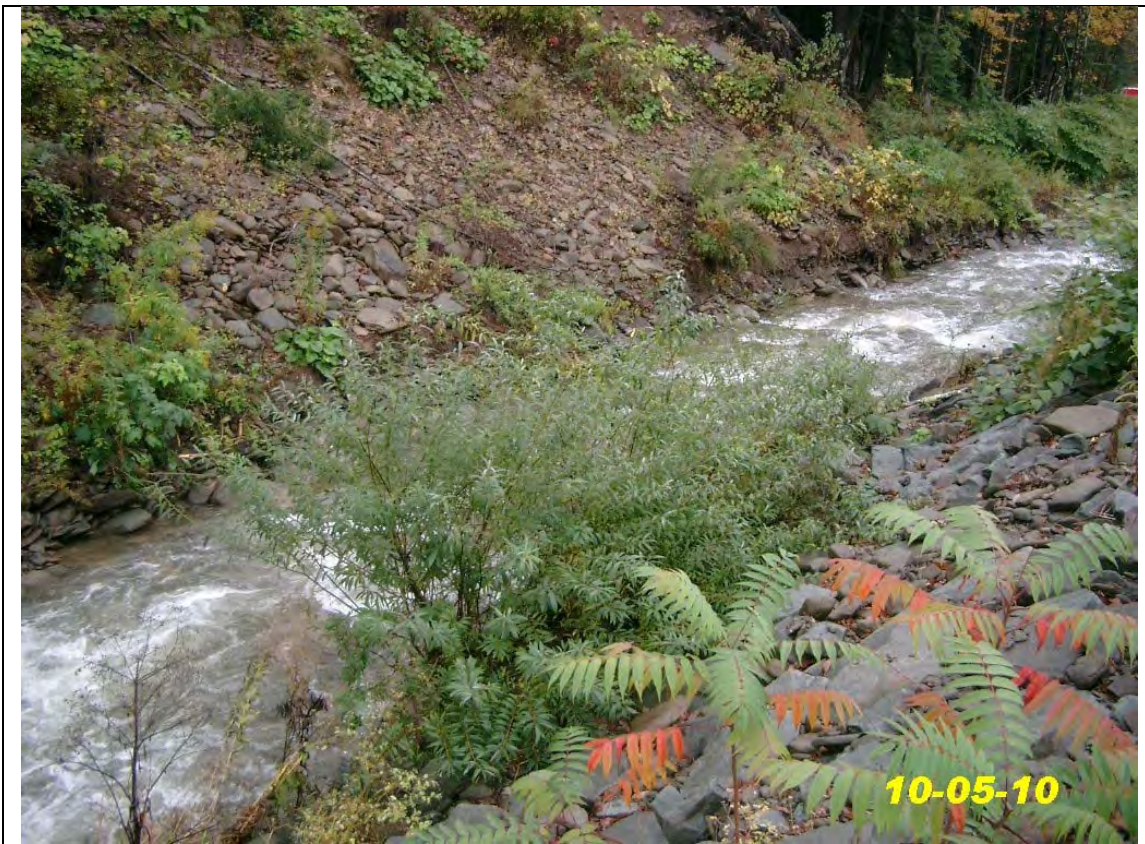
Photo 3: Looking downstream at left streambank erosion.
