EWP Streambank Protection at Baxter Brook Project Site
Before and After

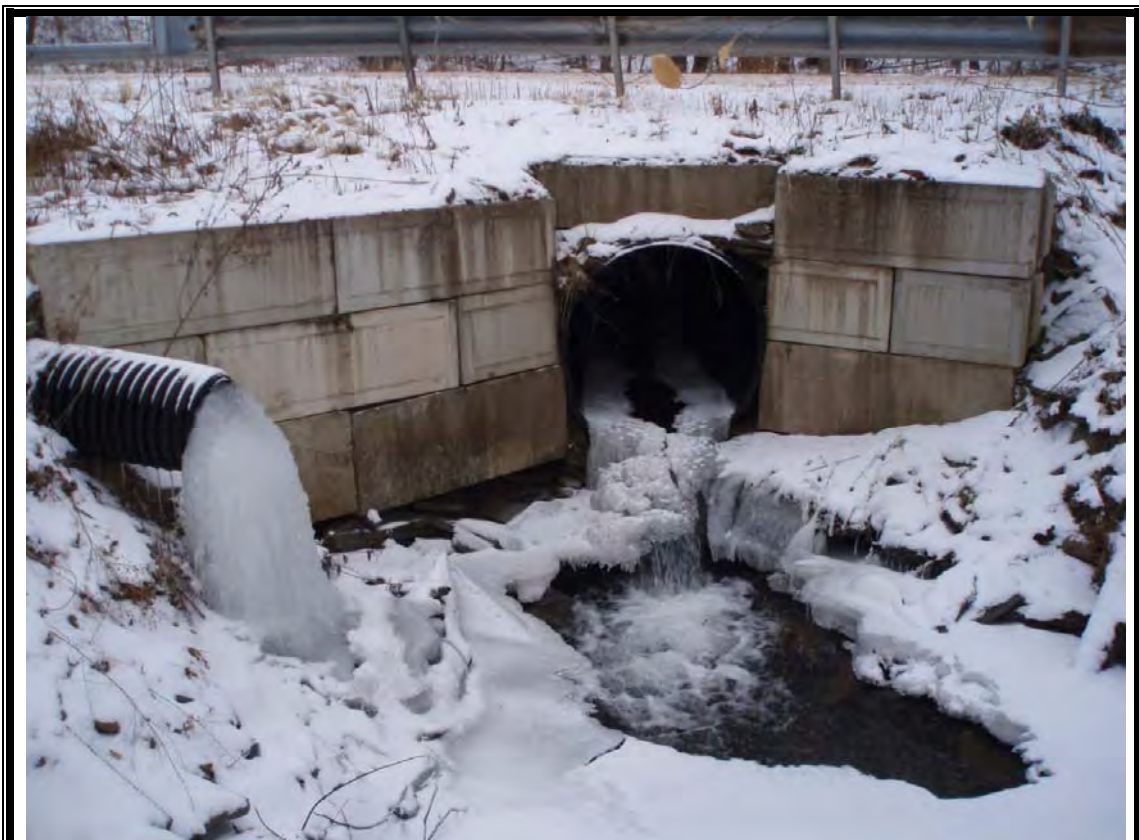
Photo 1: Looking upstream from right streambank at culvert outfall and failing head walls.

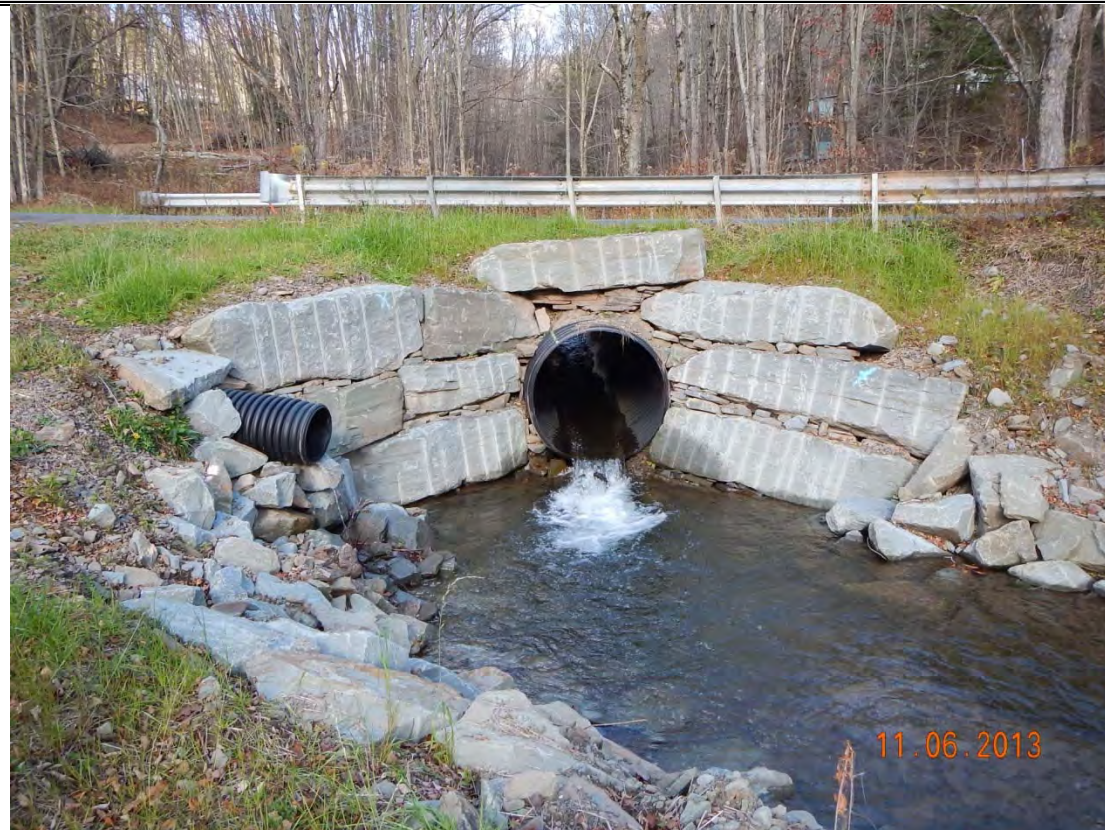
Photo 2: Looking upstream from right streambank at culvert headwall and plunge pool.

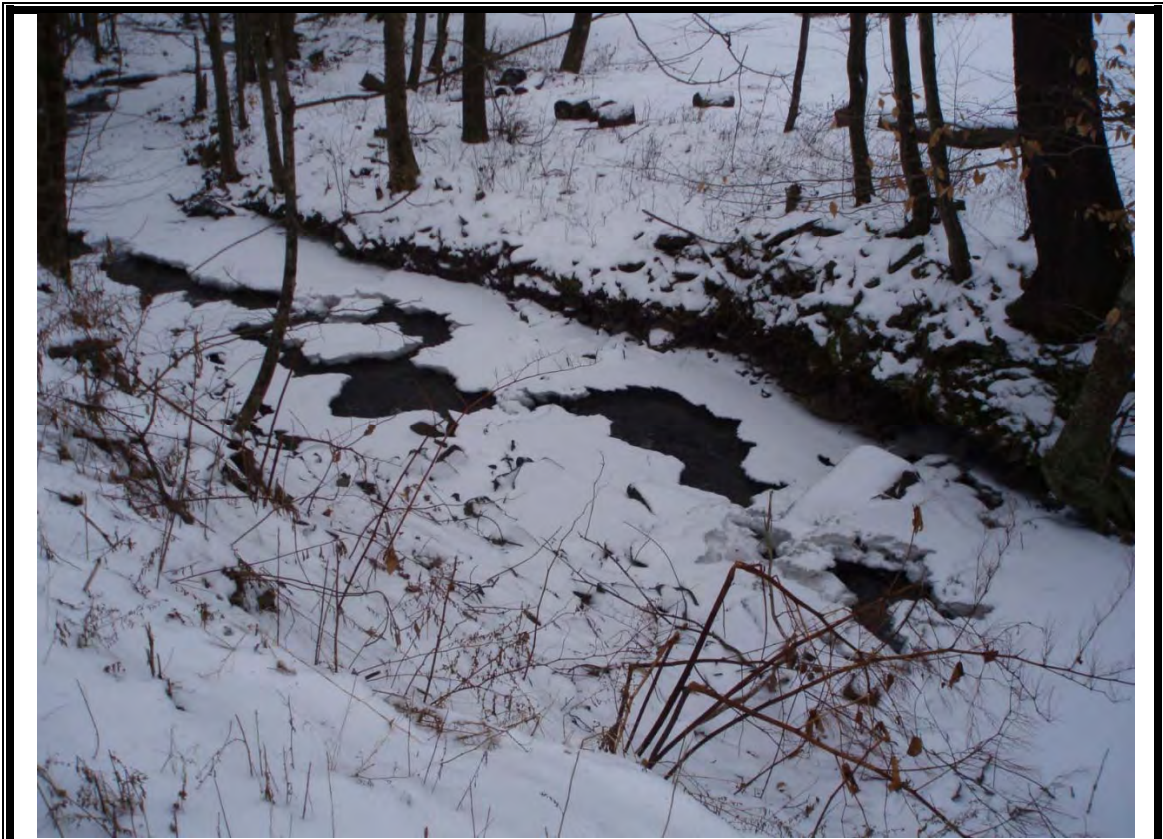
Photo 3: Looking downstream from left streambank at the streambed that has been downcutted.
